Assessment of performance of bio self-healing mortar using diatomaceous earth and silica fume

**ASSESSMENT OF PERFORMANCE OF BIO SELF-HEALING MORTAR USING
DIATOMACEOUS EARTH AND SILICA FUME**

Master of Science in Construction Engineering

May 2016

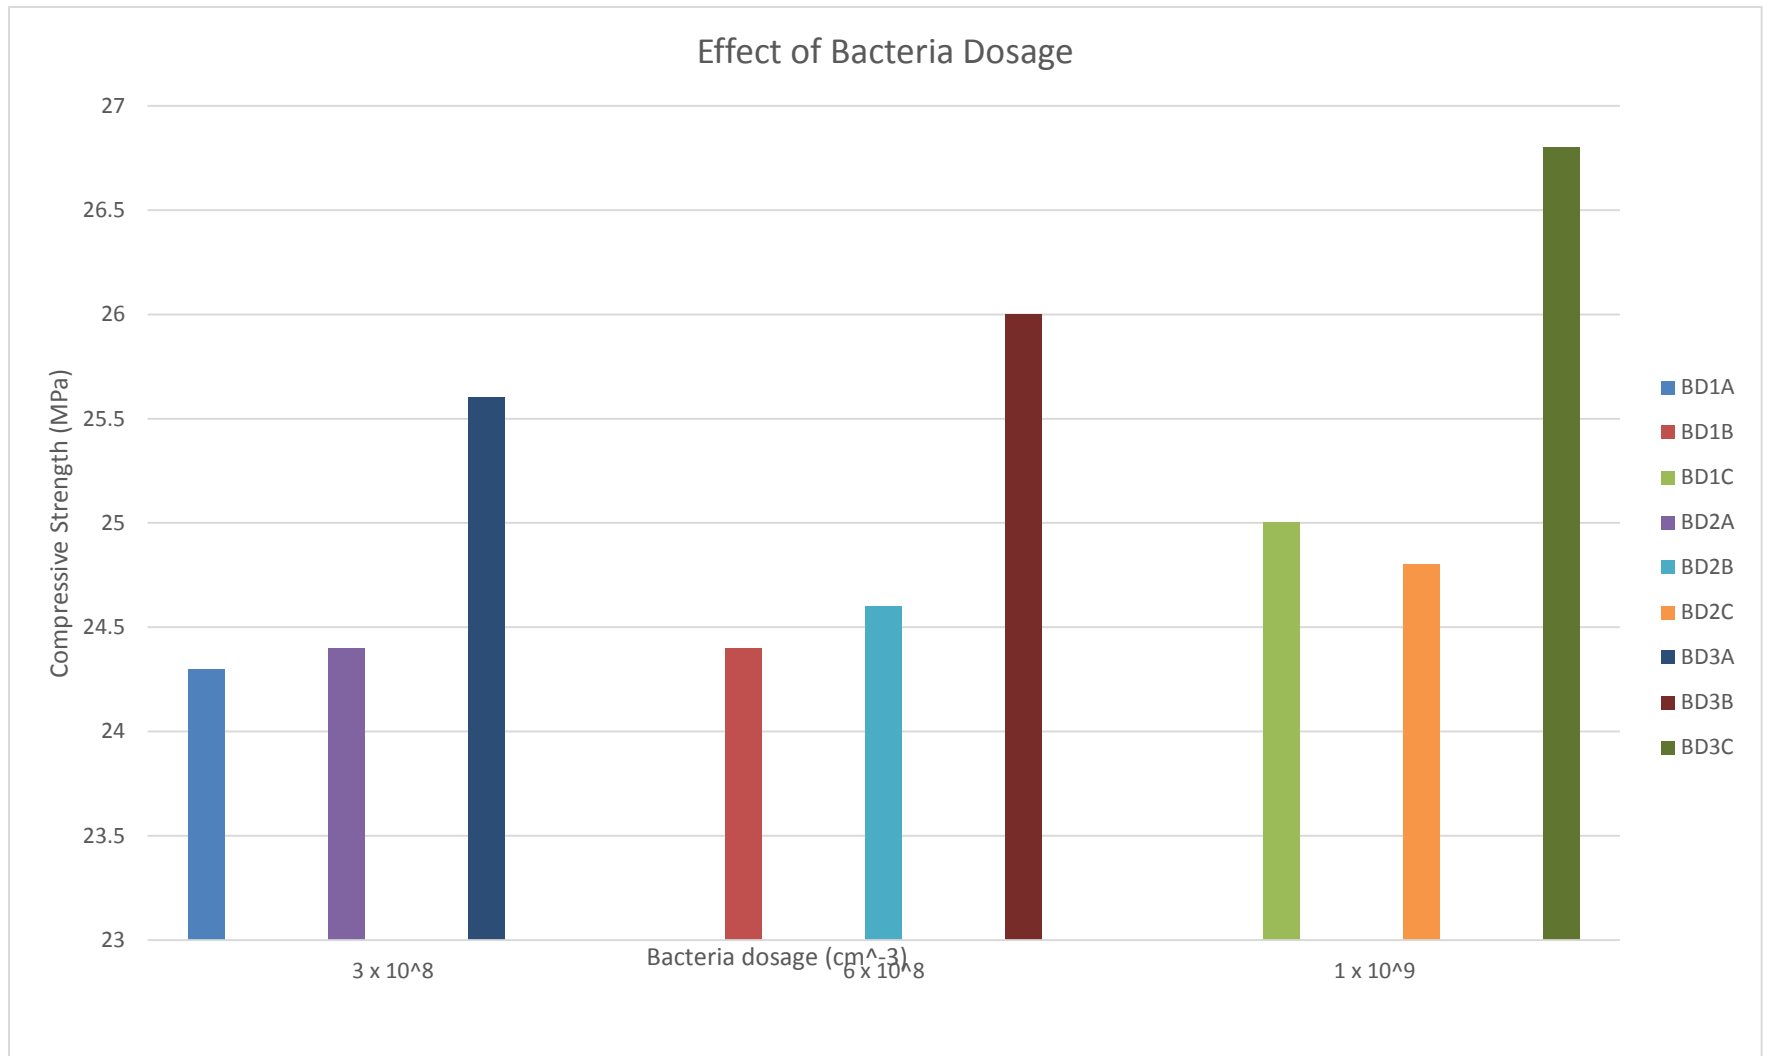
Figure 4-5: Effect of Bacteria Dossage on Compressive Strength

The fact that BD1C has a higher compressive strength than BD2C is an unclear trend and is recommended to conduct further study to better explain it.

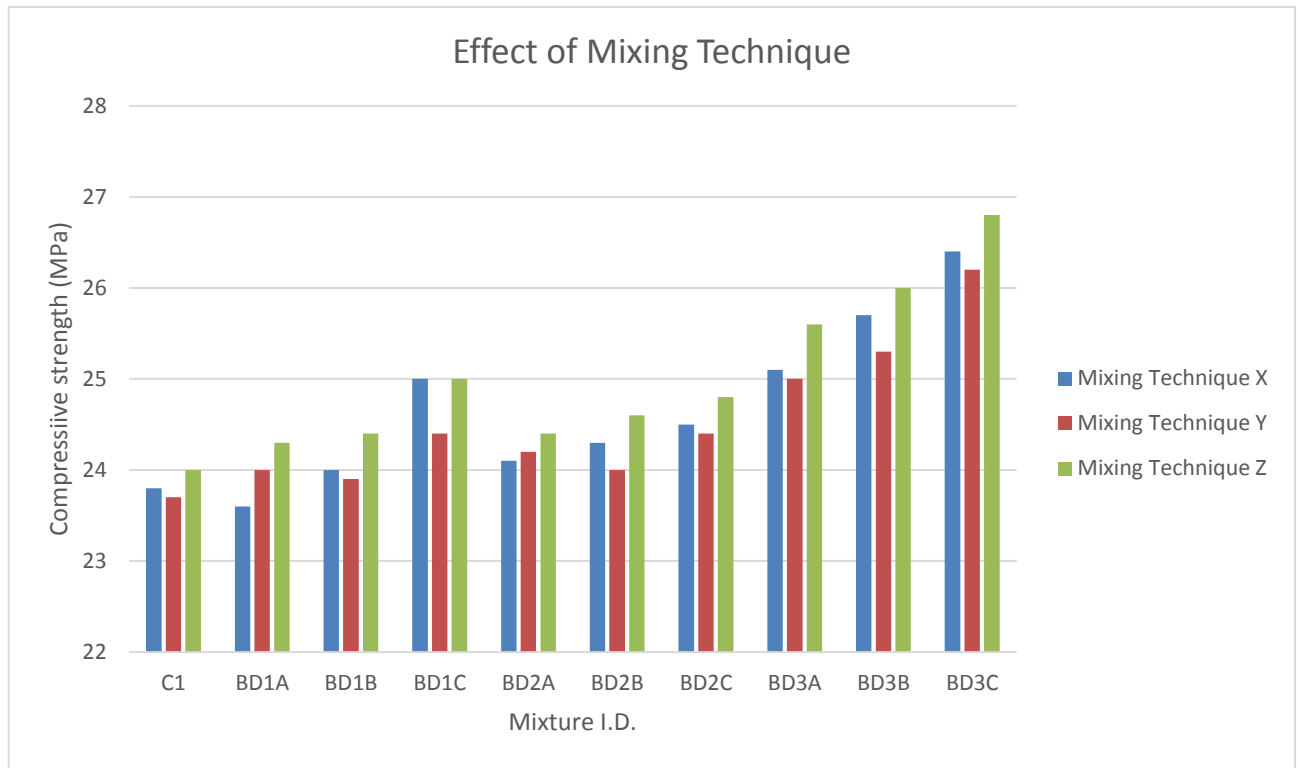
Figure 4-6: Effect of Mixing Technique on Compressive Strength

Based on the results compared in figure 4-6, it is recommended to use mixing technique (Z) which includes mixing water first with DE while conducting a dry mixing for all other components then adding the dry components to the wet DE and adding the other half of the water at the end and mixing in order to have higher compressive strength results. It is also recommended to add the water at the end in order to lessen the attraction of water by the silica fume due to its surface area and give a fair advantage of sharing water with all components.

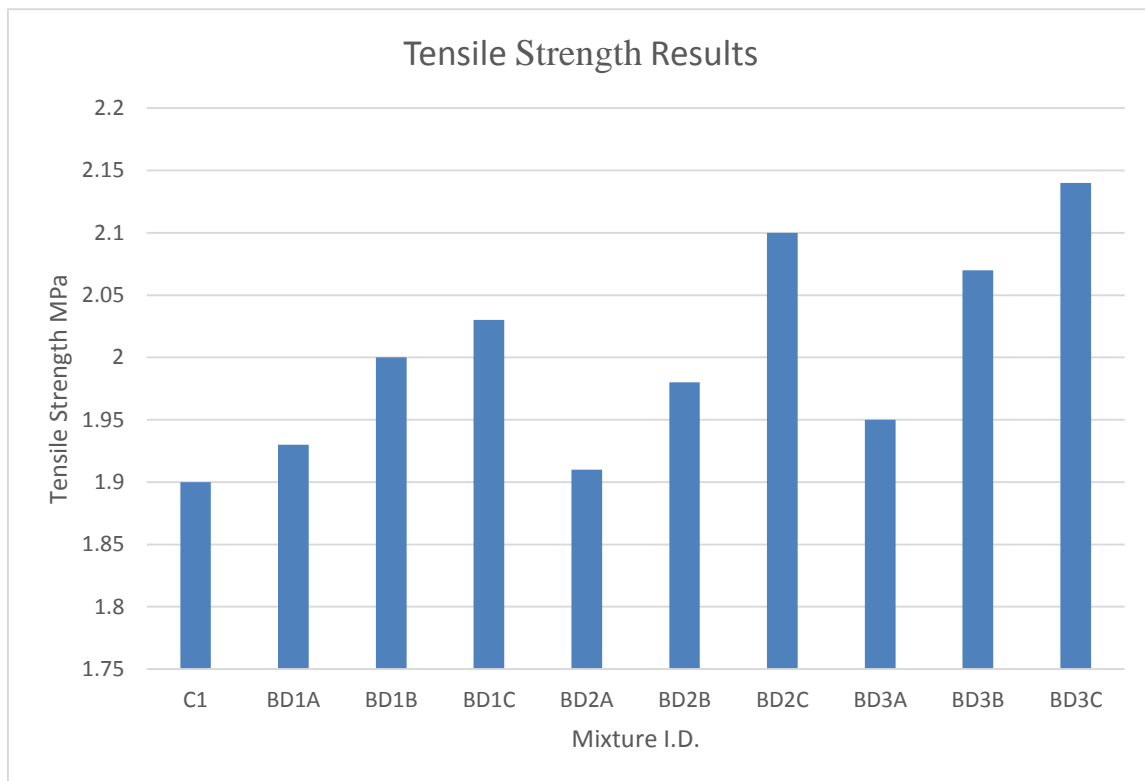
Figure 4-7 Tensile strength results at the age of 28-day

Mixture I.D.	Tensile Strength Results for Cracked Specimens	
	Tensile Strength (MPa)	Ratio of Tensile Strength to Compressive Strength
C1	1.9	7.92%
BD1A	1.93	7.94%
BD1B	2	8.20%
BD1C	2.03	8.12%
BD2A	1.91	7.83%
BD2B	1.98	8.05%
BD2C	2.1	8.47%
BD3A	1.95	7.62%
BD3B	2.07	7.96%
BD3C	2.14	7.99%

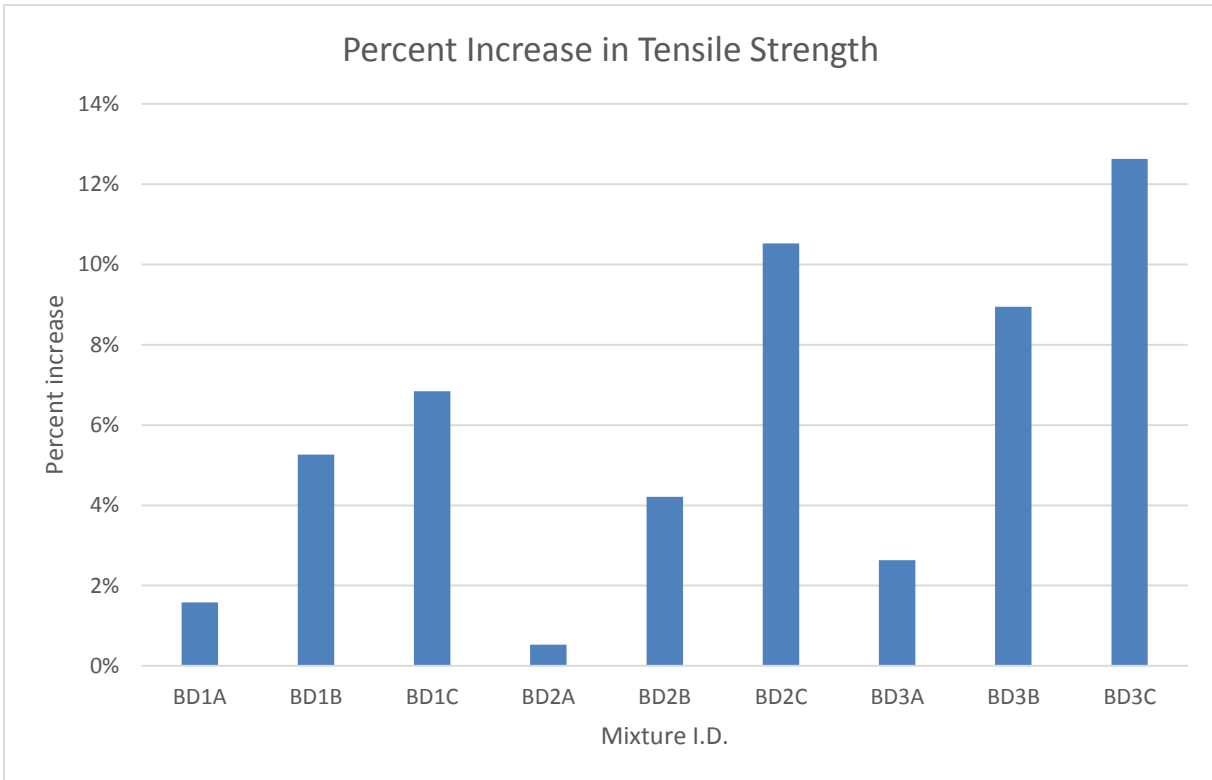
Figure 4-8: Percent increase in Tensile Strength

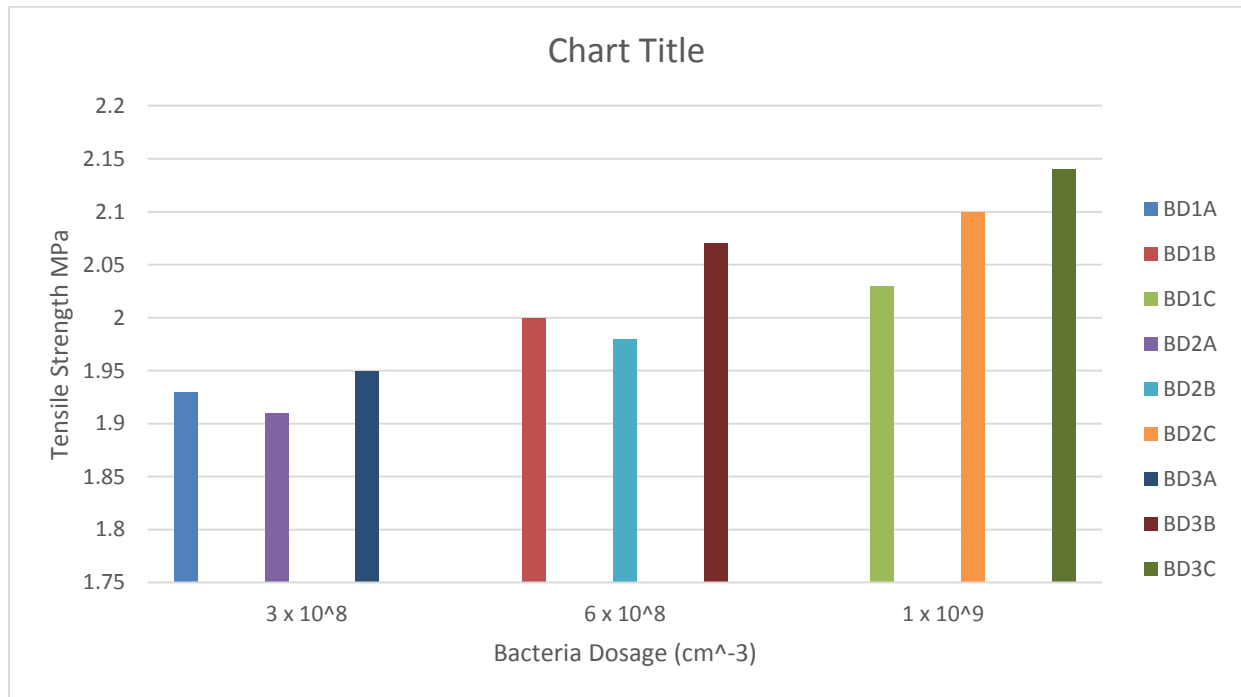
Figure 4-9: Effect of Bacteria Dosage on Tensile Strength

the different specimens is likely what contributed to the overall integrity of specimens and accordingly higher tensile strength.

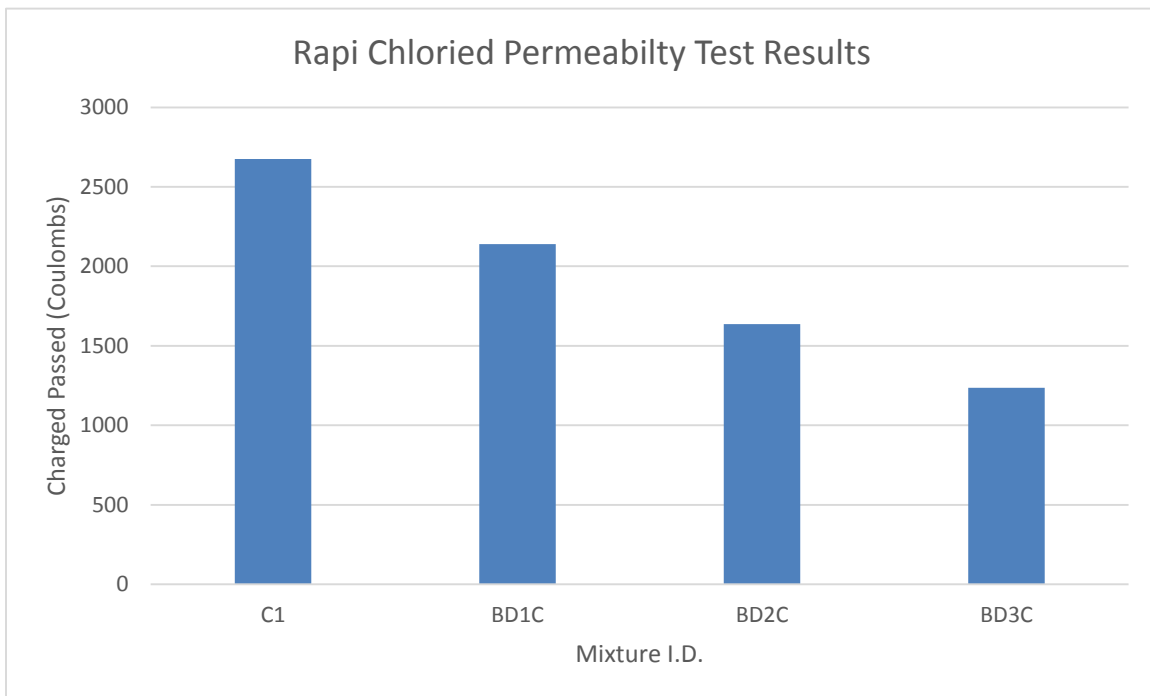
Figure 4-10: Rapid chloride permeability test results

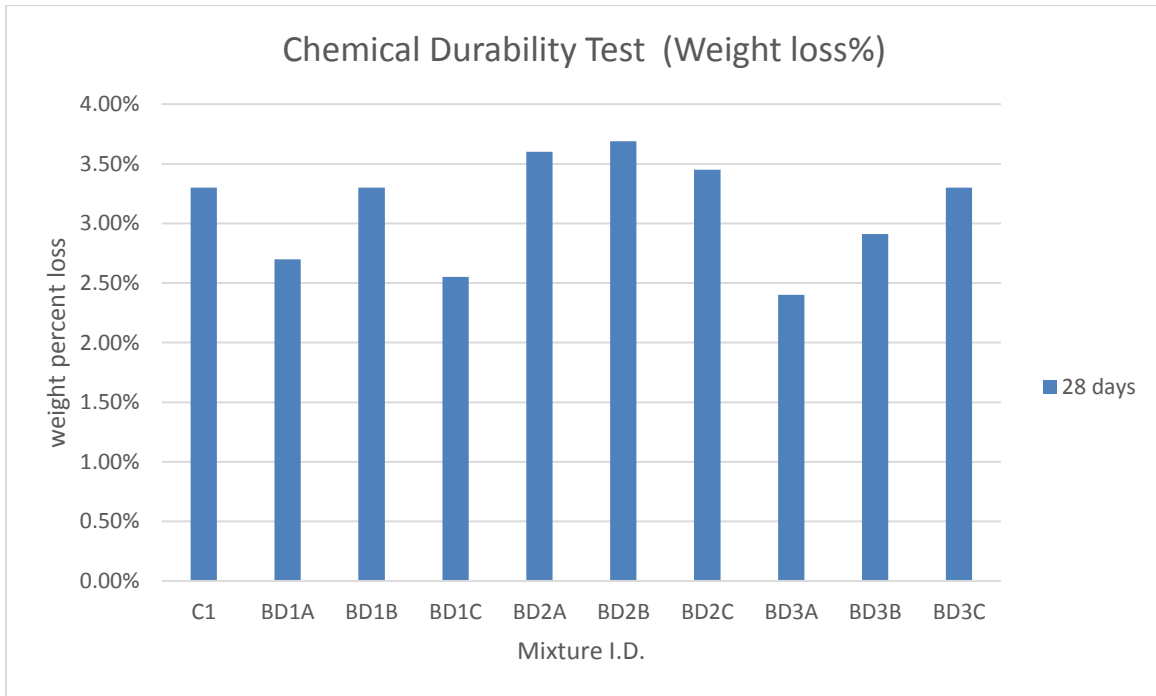
Figure 4-11: Mass loss percentage due to exposure to magnesium sulfate

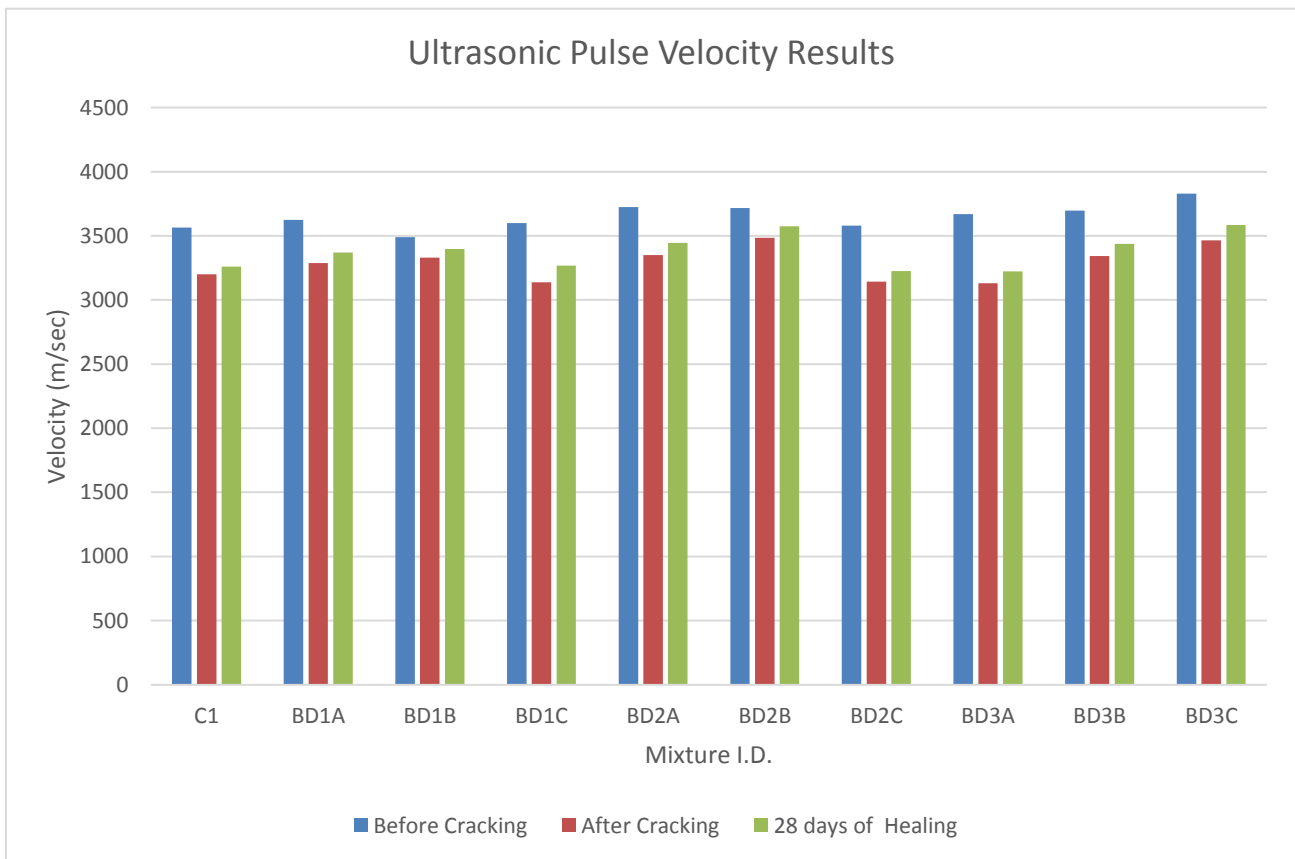
Figure 4-12: Ultrasonic Pulse Velocity of cracked specimens after 28 days of healing

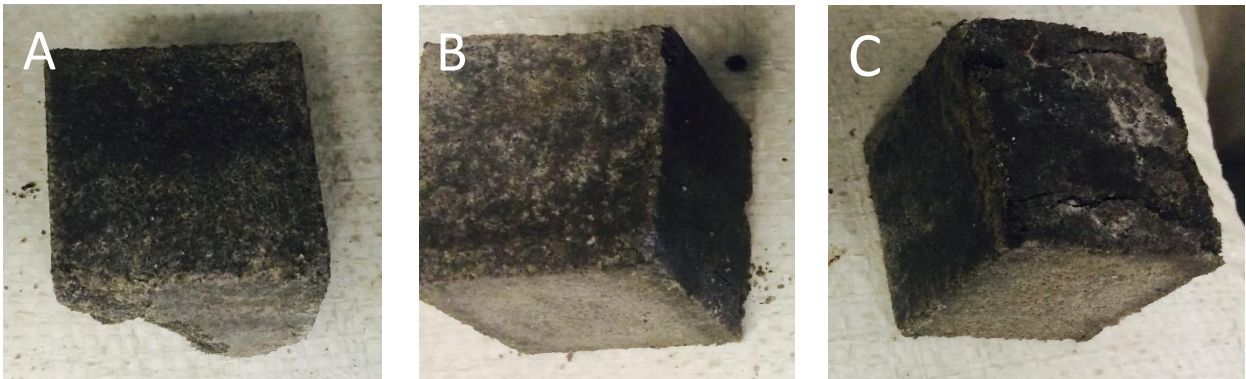
Figure 4-13: A: Specimen BD1A, B: Specimen BD2B presenting precipitation of calcite on the surface of the cube; C: Specimen BD3C showing healing of few surface Cracks.

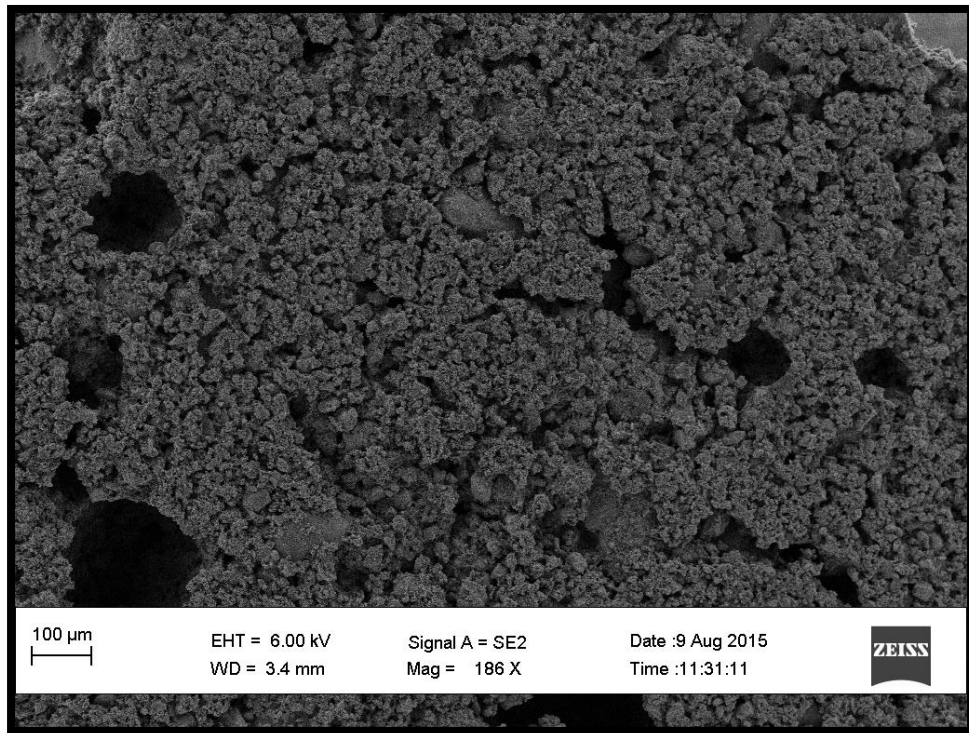
Figure 4-14: SEM Picture of C1 at 28 days

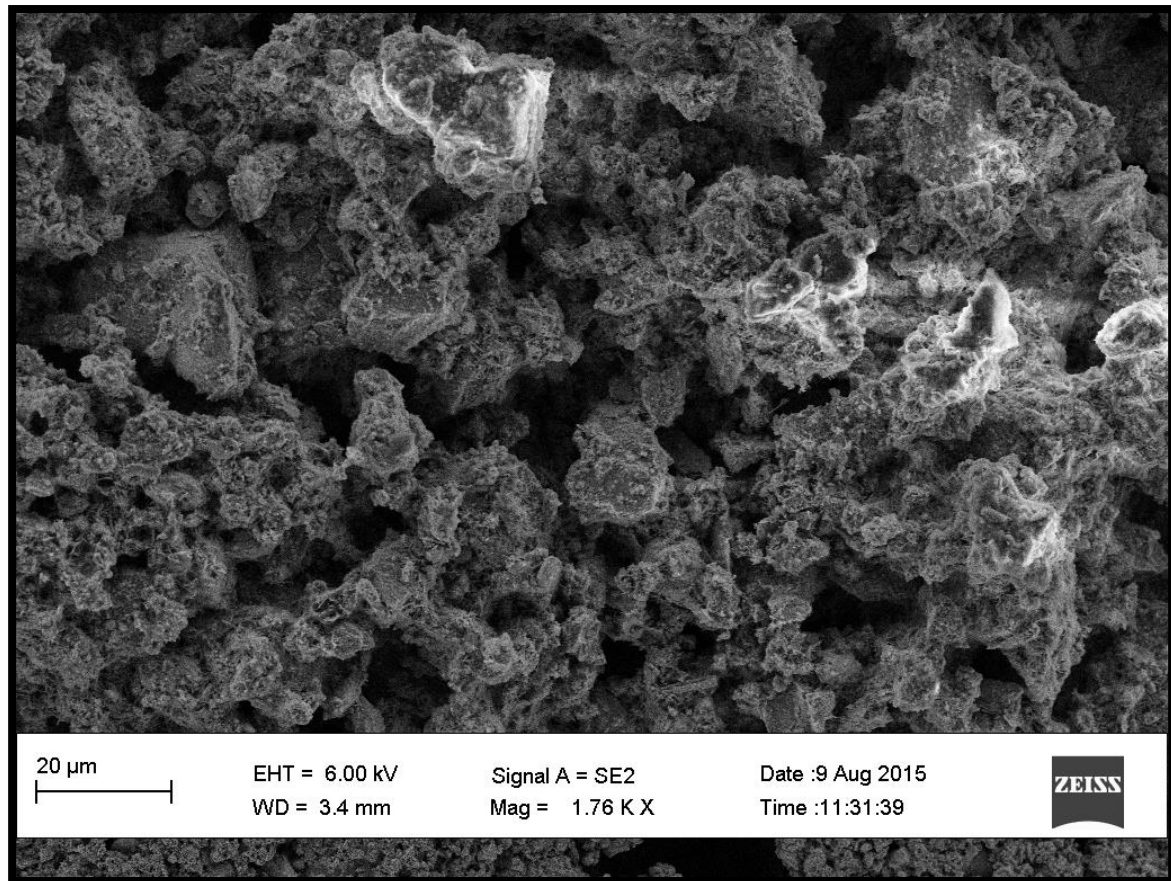
Figure 4-15: SEM Picture of C1 at 20 micrometer at 28 days

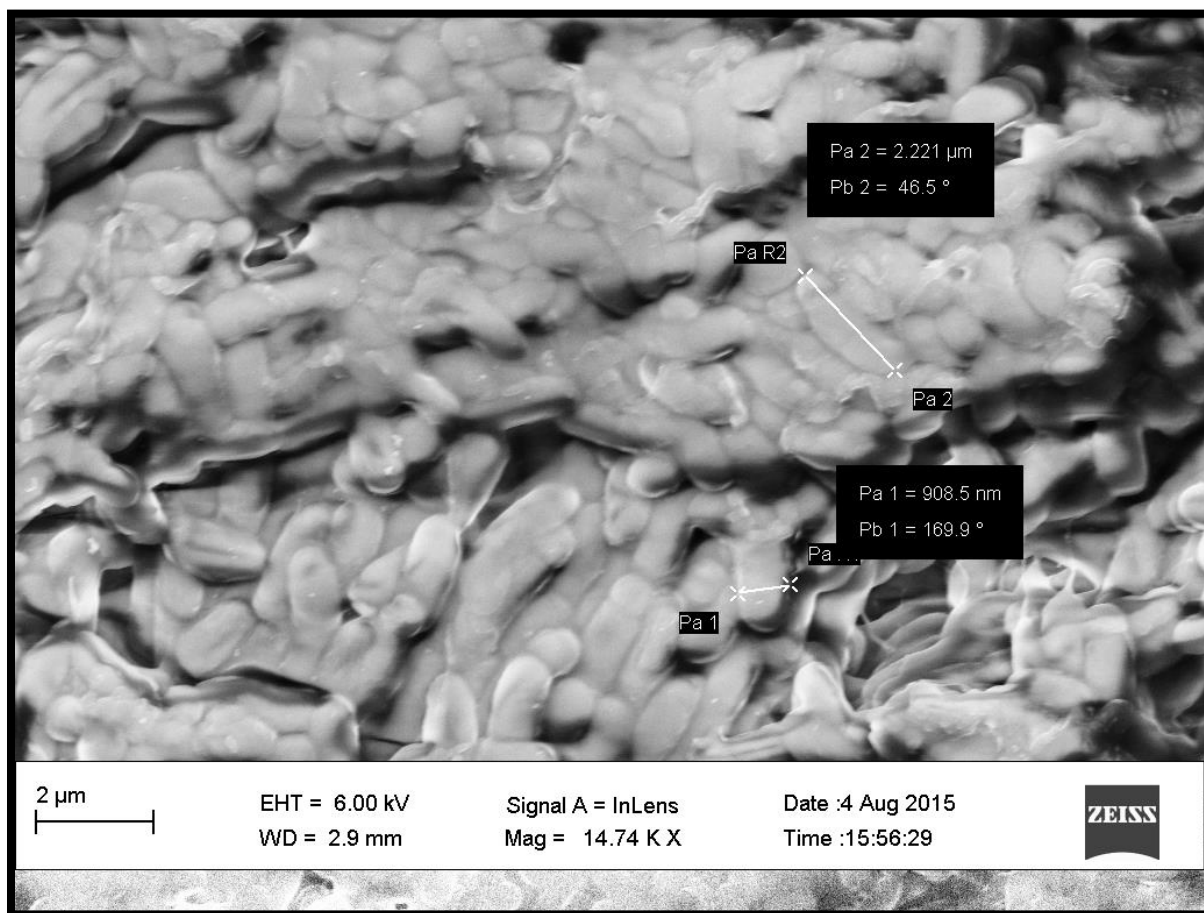
Figure 4-16: SEM Picture of a cluster of *Bacillus Pseudofirmus* DSM 8715 strains

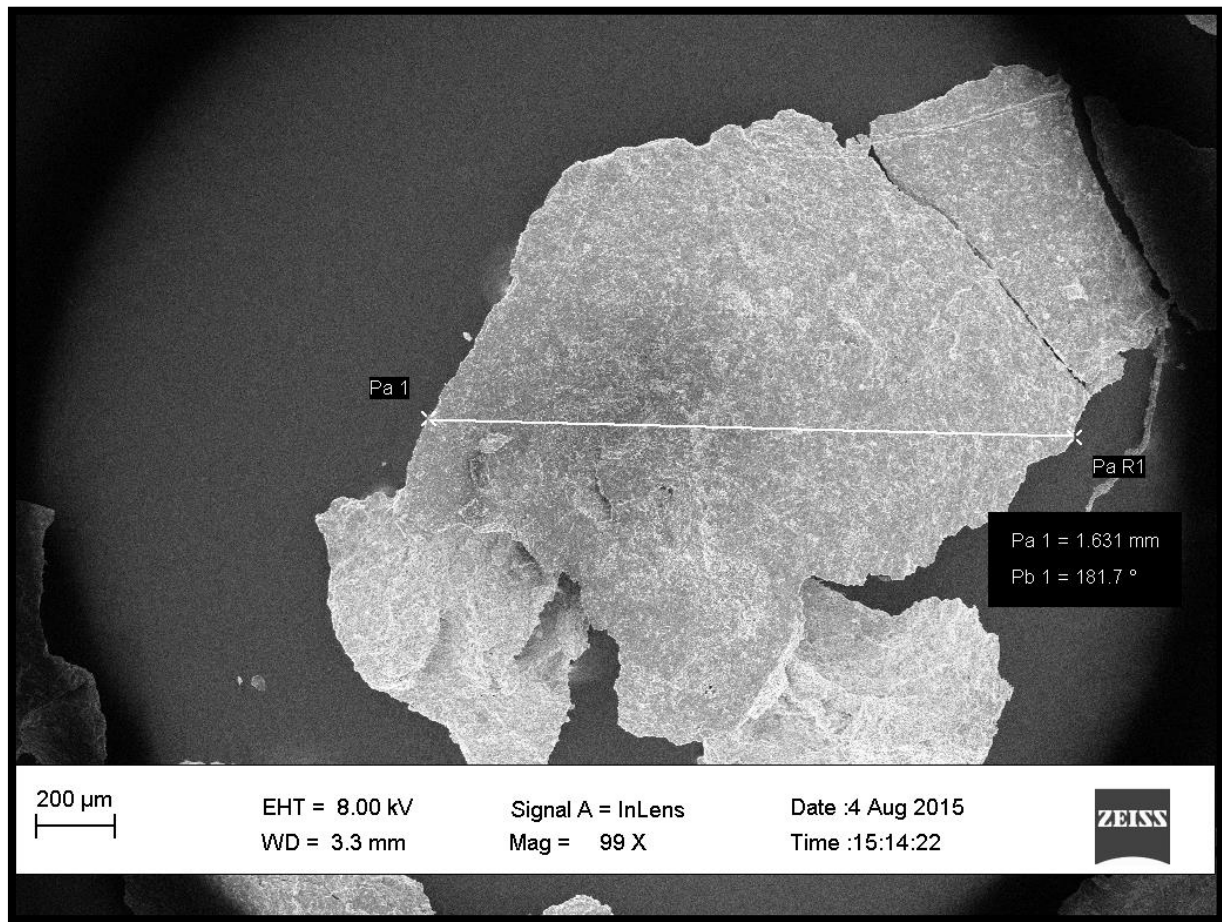
Figure 4-17: SEM Picture showing a dimension of Burned Bentonite Particle

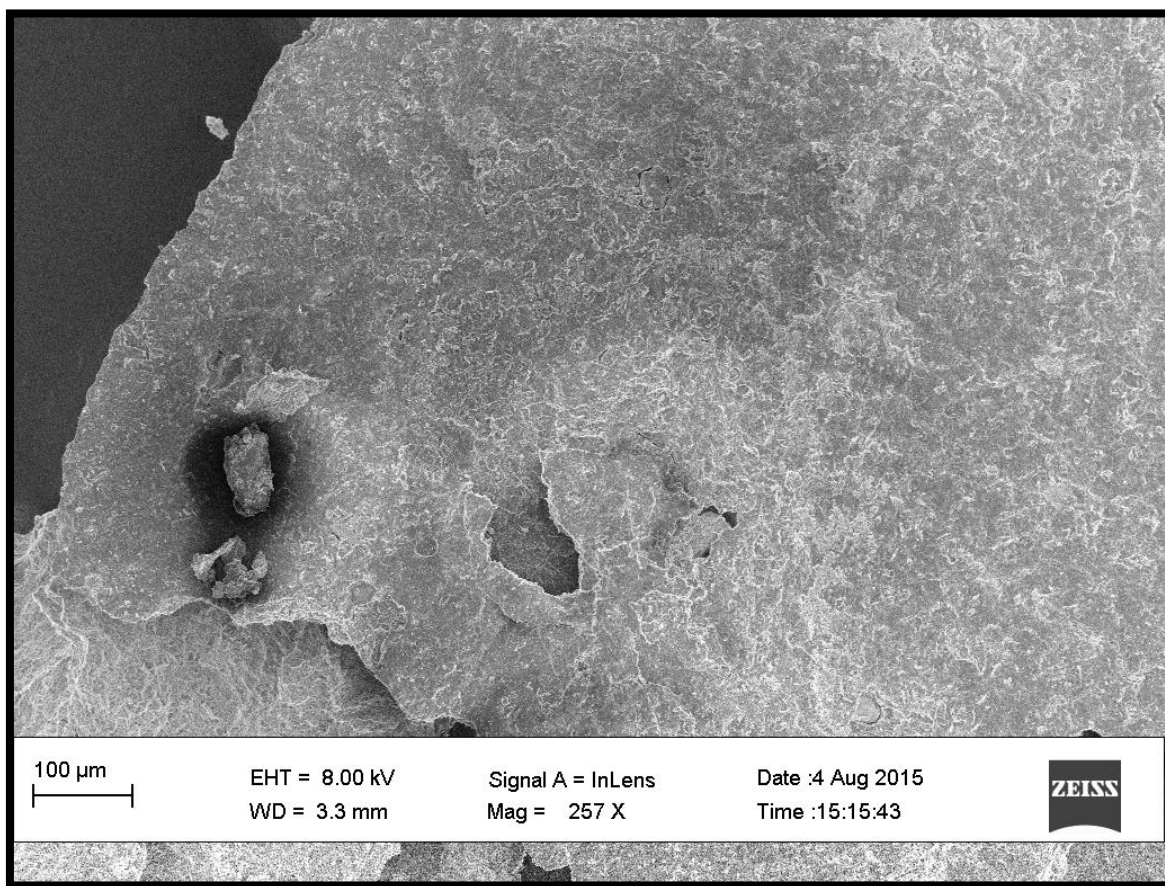
Figure 4-18: SEM Picture of Burned Bentonite Particle

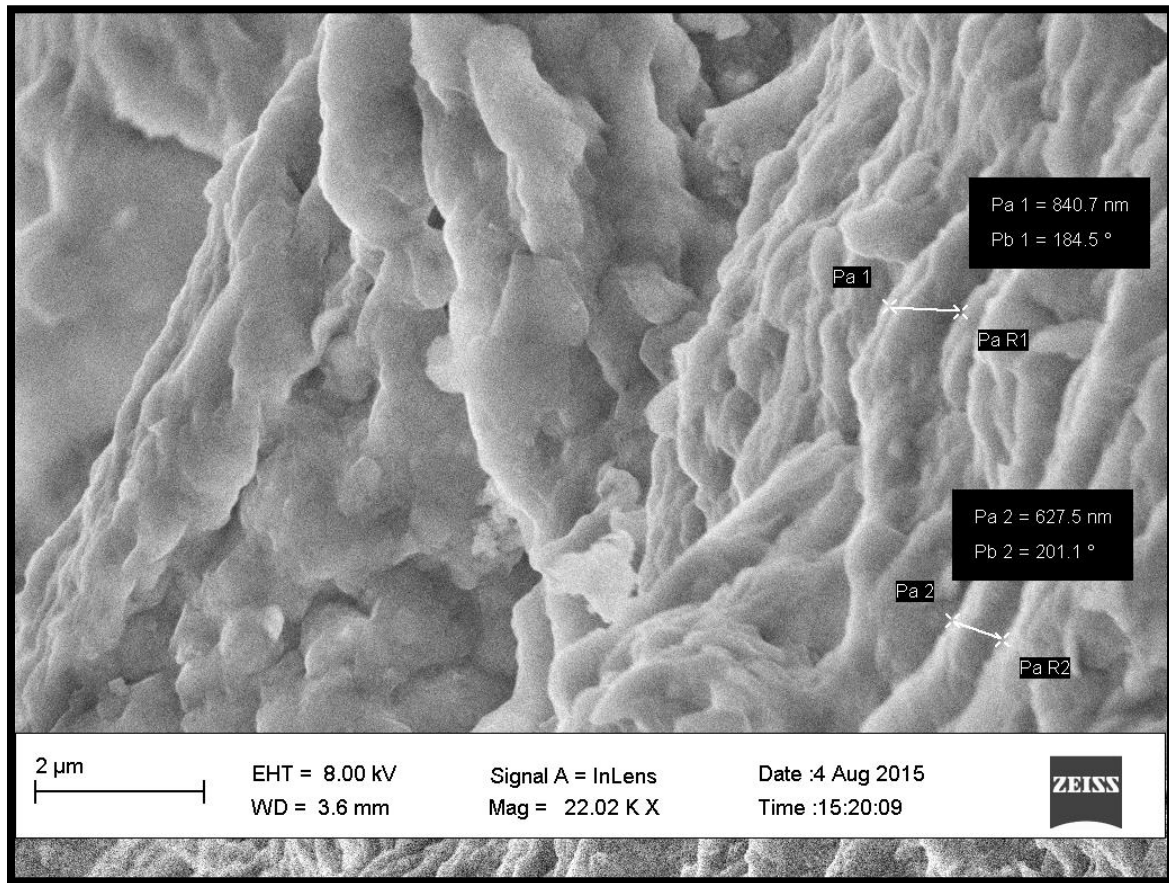
Figure 4-19: SEM picture of a burned Bentonite surface

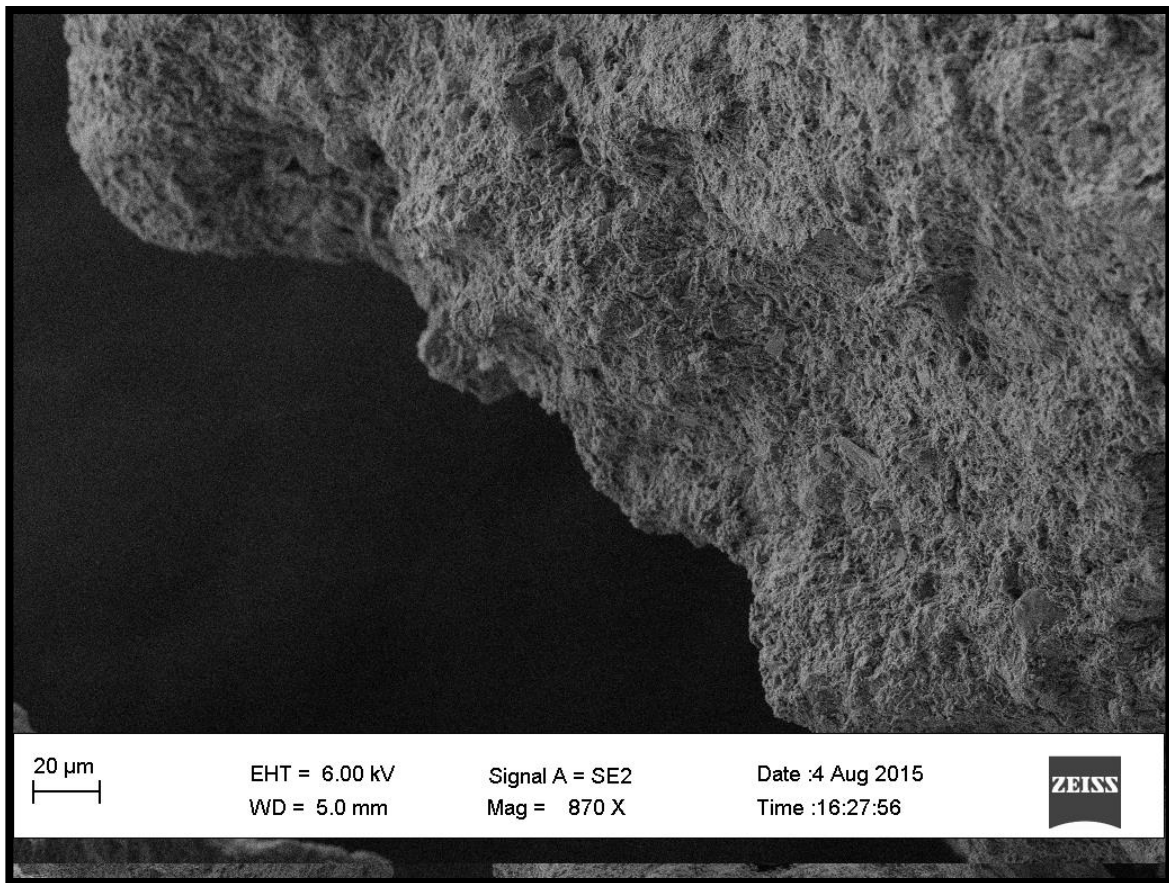
Figure 4-20: SEM Picture of a mortar particle with a spread of bacteria on its surface –BD1C

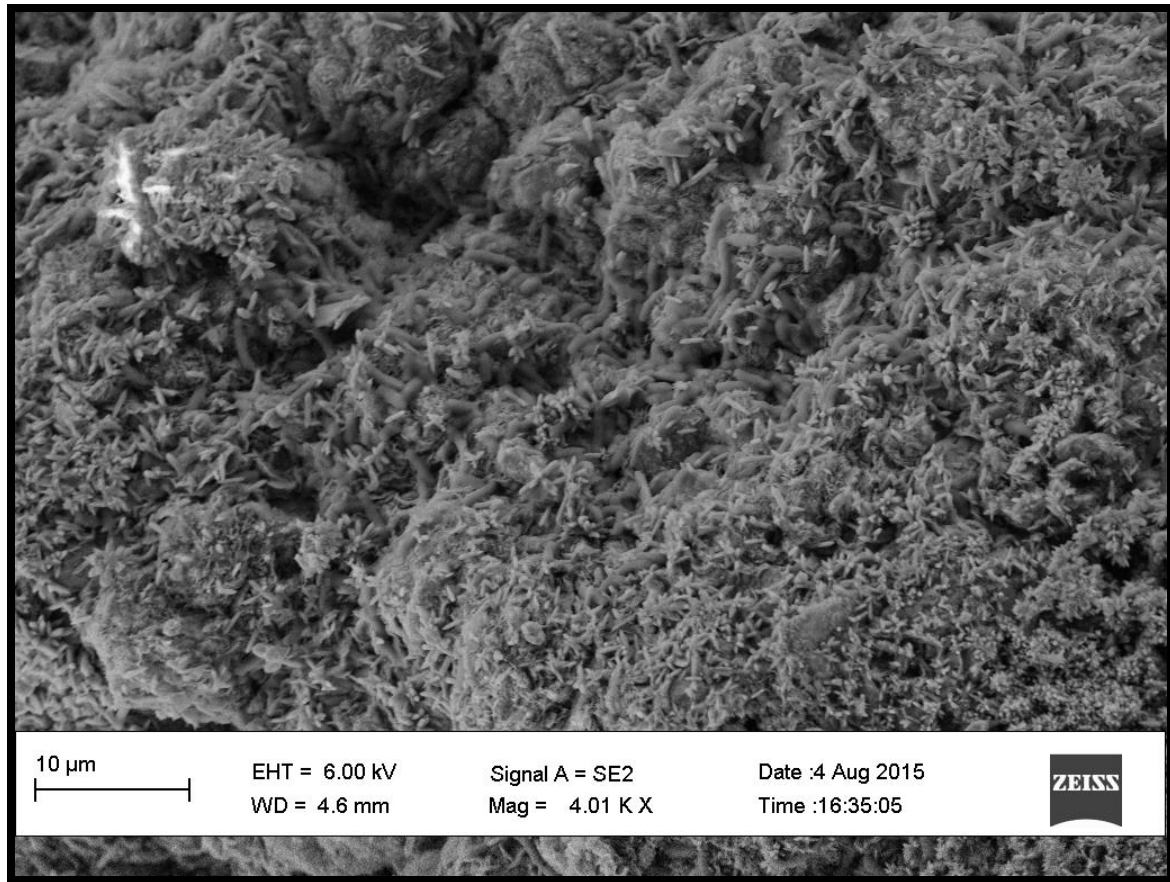
Figure 4-21: SEM picture of bacteria on the surface of a mortar particle BD1C

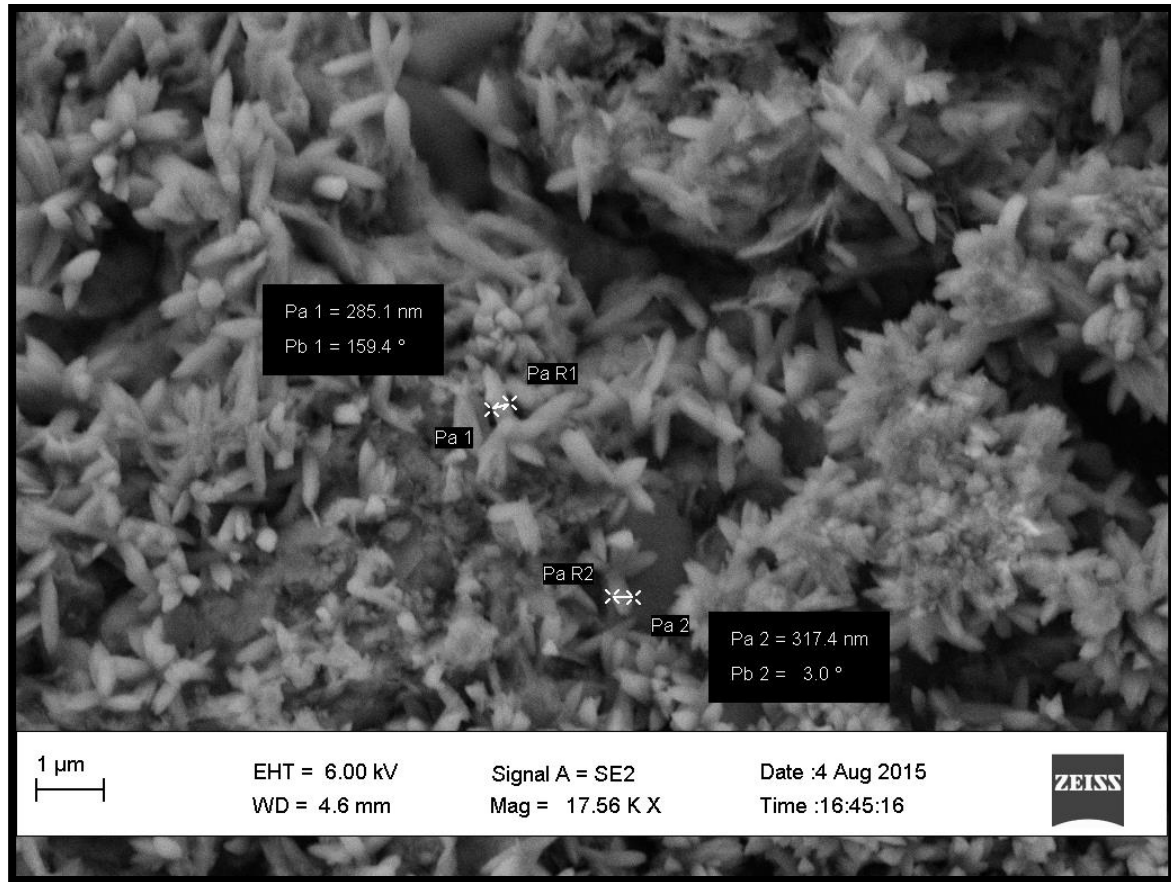
Figure 4-22: SEM picture of vegetative bacteria on a mortar particle BD1C

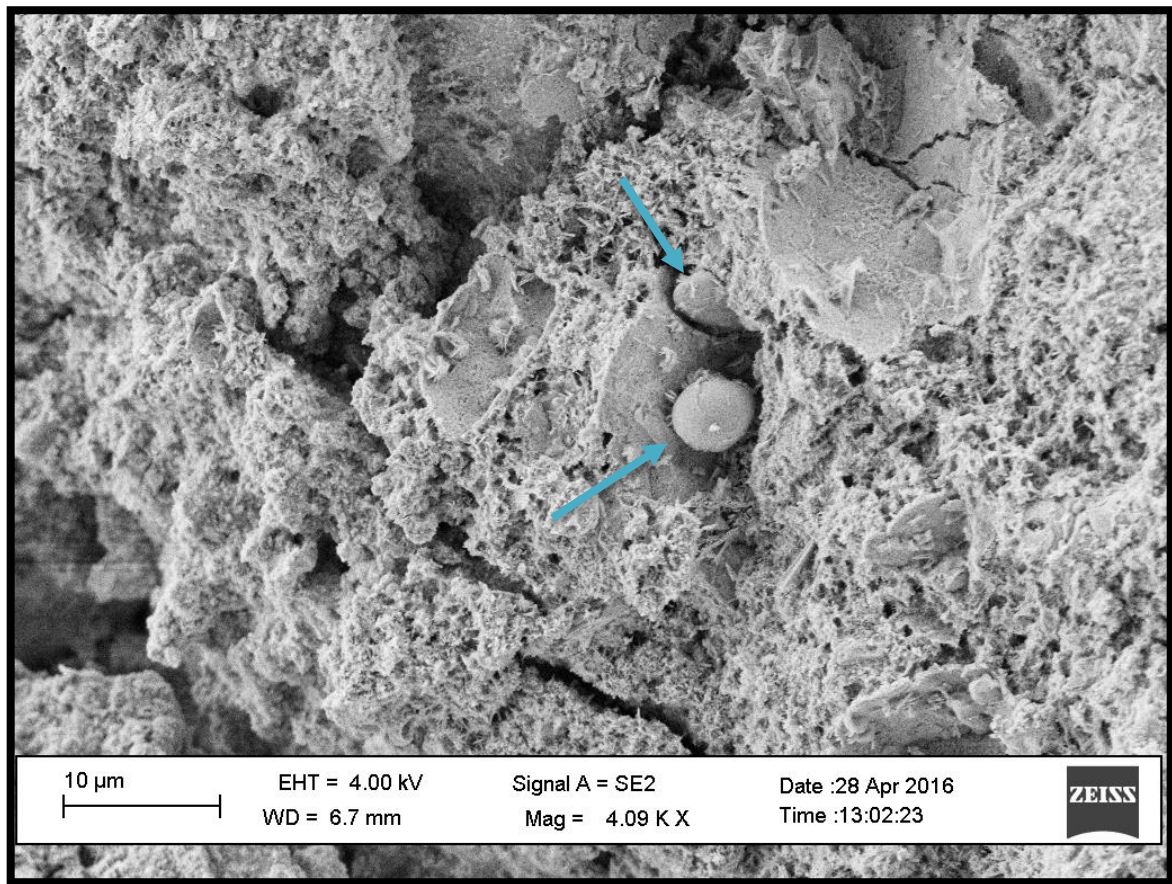
Figure 4-23: SEM picture of BD3C

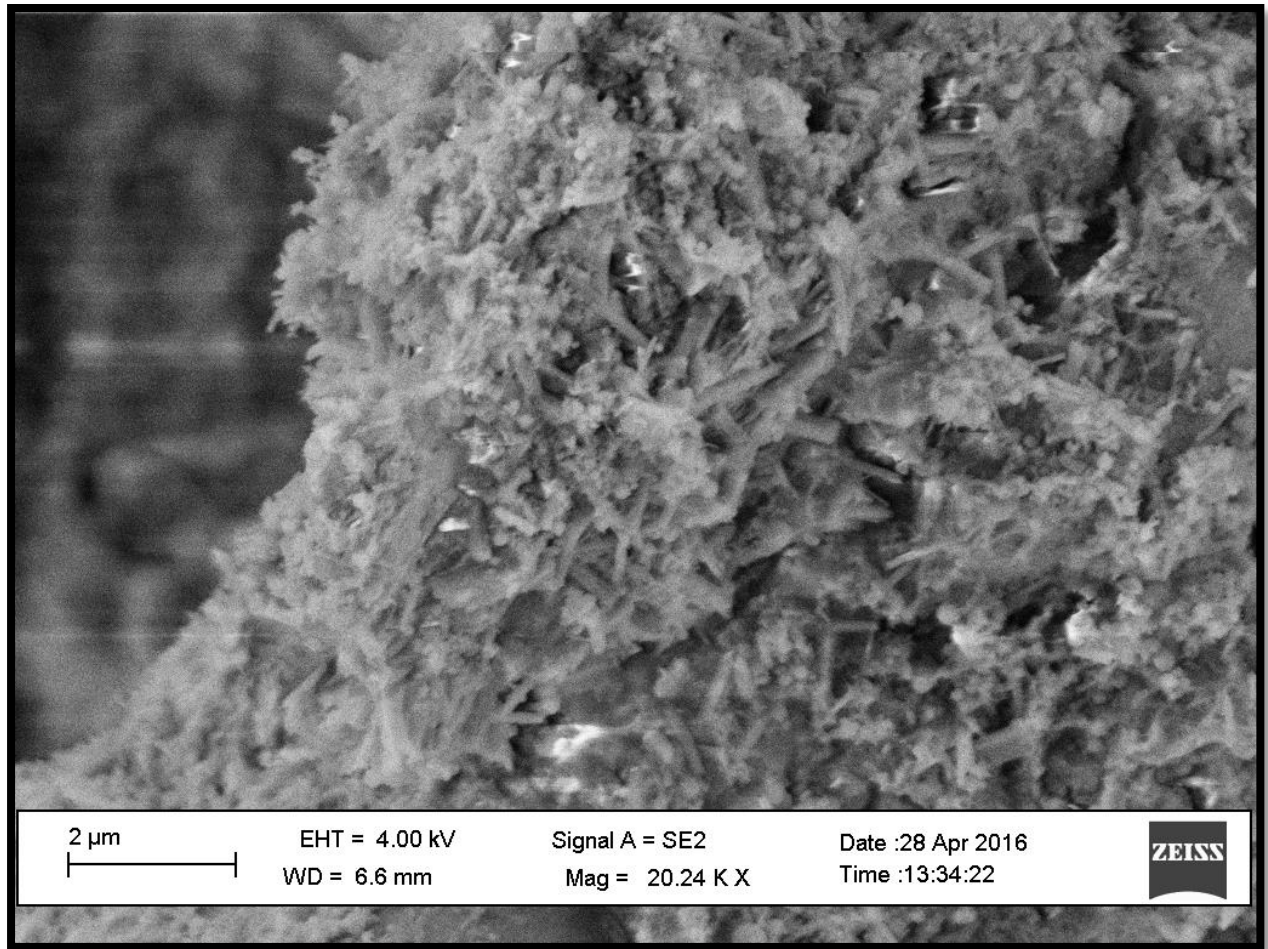
Figure 4-24: SEM picture of BD2C

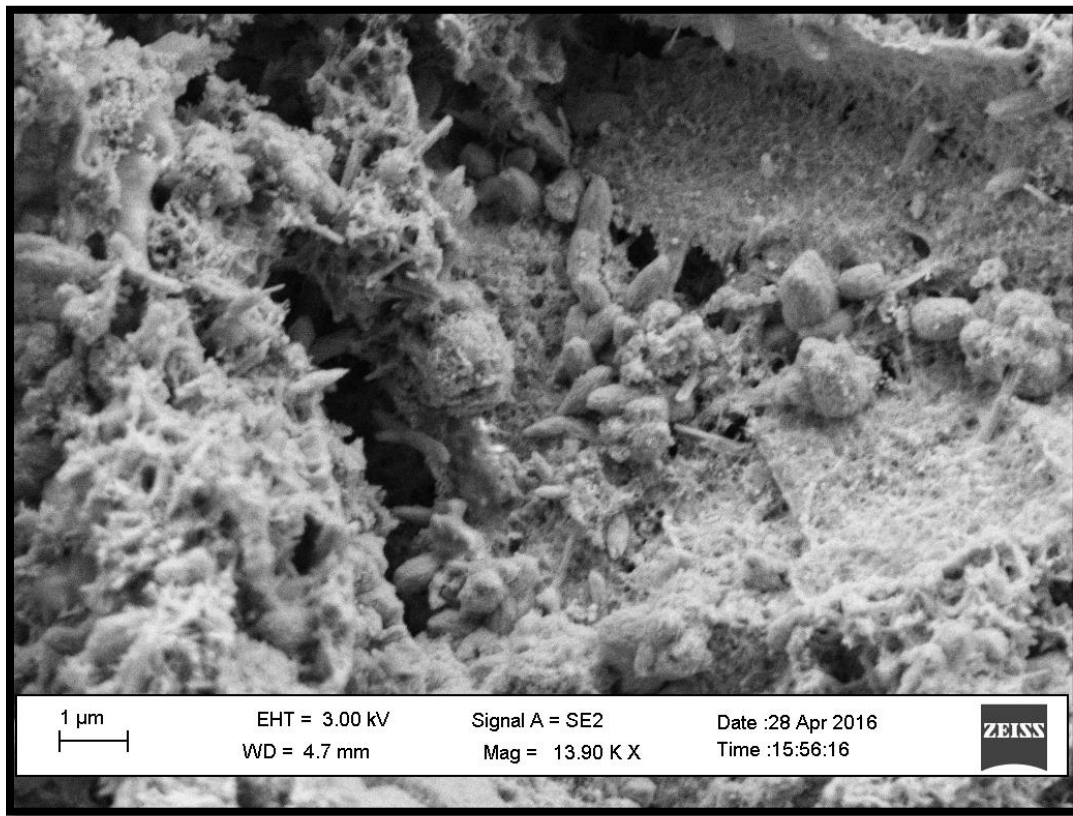
Figure 4-25: SEM Picture of BD3C
